Eames House Conservation Project: Investigations 2011 to 2016

Research Report

CHAPTER 2

In Situ Paint Investigation of the Exterior Steelwork of the Eames House Residence and Studio

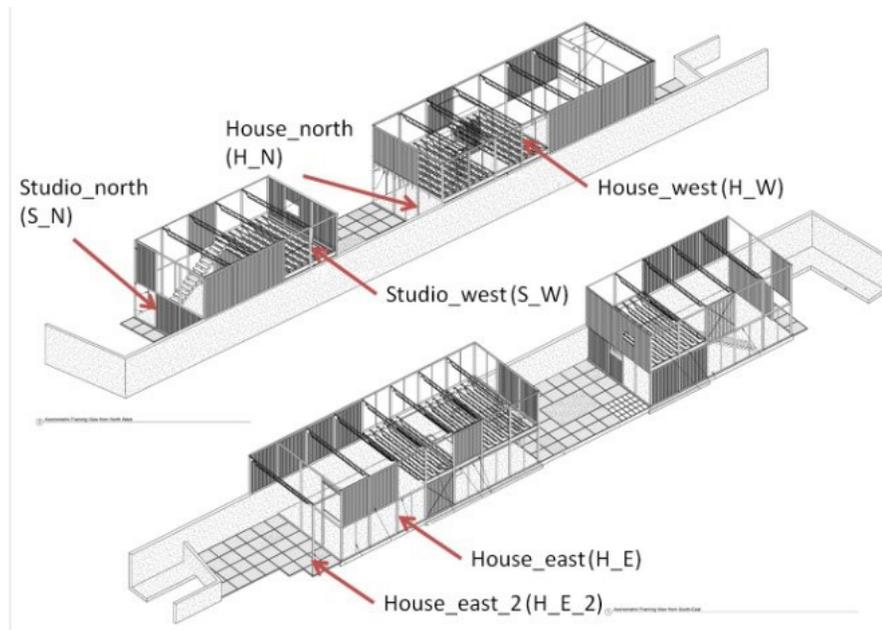
FIGURE 2.2
Locations of in situ paint excavation sites.

The in situ paint investigation is focused solely on the paint on the exterior steel framework of the Eames House. Six in situ paint excavation exposure windows, and complementary cross-sectional optical microscopy, were carried out on the exterior steel beams on the north, east, and west elevations of the residence and on north and west elevations of the studio (fig. 2.2). The paint excavation sites (sample sites) were selected based on proximity to sampling sites undertaken in 2011, and on the need to study different elevations.

- House_north (H_N) – June 20 2012
- House_east (H_E) – July 3 2012
- House_west (H_W) – July 20 2012
- Studio_north (S_N) – July 20 2012
- Studio_west (S_W) – July 20 2012
- House_east_2 (H_E_2) – October 10 2012

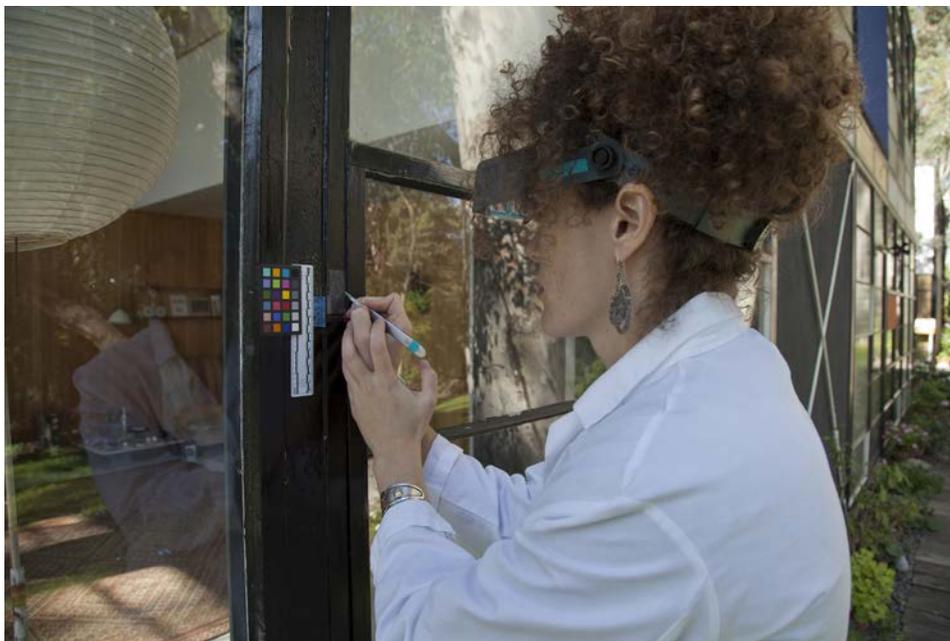
FIGURE 2.3

Emily MacDonald-Korth excavating exterior paint layers at the Eames House (sample location House_east), 2013.

Using a small stainless steel scalpel blade and other mechanical techniques, each paint layer was carefully scraped and cleaved away to reveal the layer beneath, from the steel substrate to the uppermost paint layer (figs. 2.3–2.4). The sizes of the exposure windows varied; they were approximately 1 × 1–2.5 in. (2.5 × 2.5–6.4 cm). Observations made during in situ examination were written and recorded with digital photo documentation before and after excavation. A digital microscope was also used to photograph select sample sites. Sample sites are not visually distracting from a distance, but are large enough to reveal the color of each layer when viewed up close.

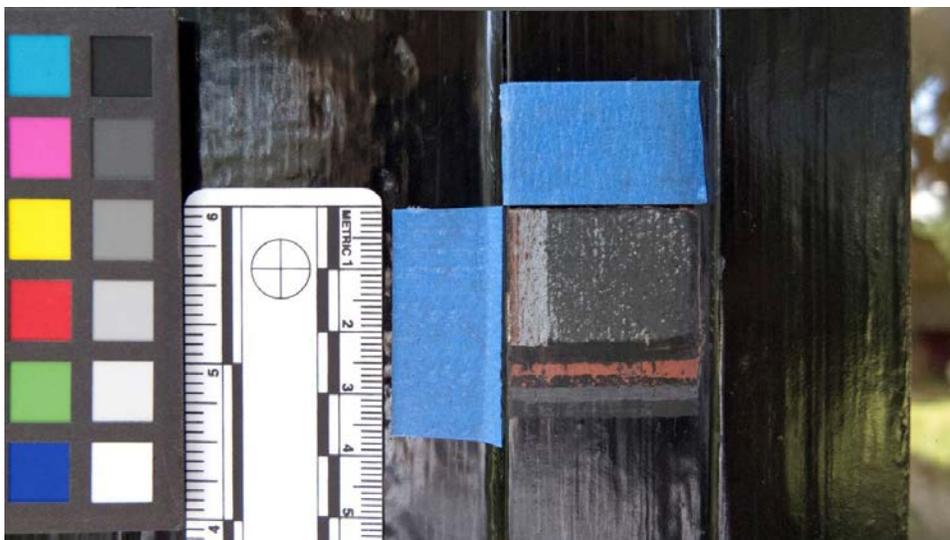
**FIGURE 2.4**

Detail of in situ paint excavation exposure window (H_E) after completion.

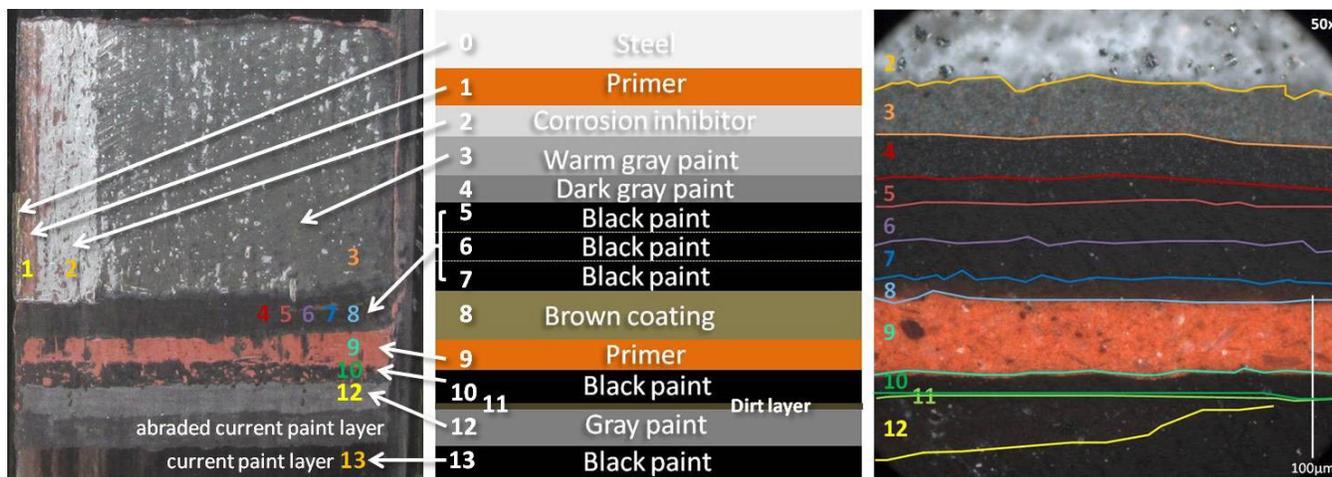
FIGURE 2.5
In situ paint excavation exposure window after completion (H_E), with layers numbered chronologically from lowest (earliest, number 0) to uppermost (most recent, number 13), and annotations where necessary.

FIGURE 2.6
Paint layering structure diagram (not to scale), with arrows referring to the adjacent exposure window diagram.

FIGURE 2.7
Photomicrograph of cross-sectional sample taken from the exposure window in figure 2.5 (H_E). Layers are delineated and numbered.

From the results of the in situ investigation, a general paint stratigraphy for the exterior steelwork of the residence and studio can be summarized as follows. The steel substrate shows one to three layers of primer and a corrosion inhibitor, followed by a warm gray paint. A dark gray paint was applied at some time, followed by a series of one to three black paints. The black paint was then coated with a shiny brown material, followed by a black paint and then a gray paint, before the current black paint was applied (figs. 2.5–2.7).

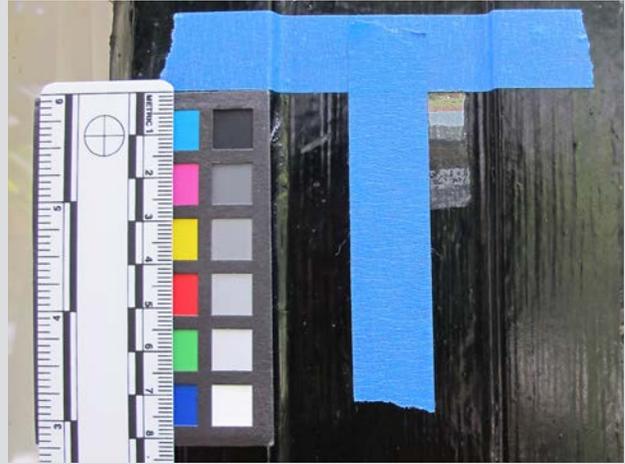
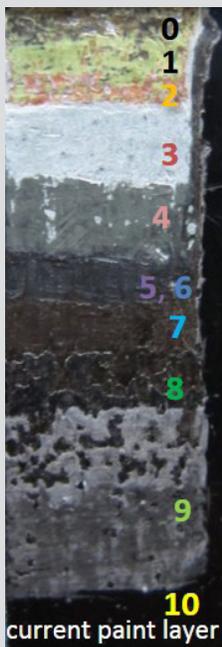
FIGURE 2.8B
House_north, in situ paint excavation exposure window.

FIGURE 2.8C
House_north, in situ paint excavation exposure window.

Detailed observations from each sample site and associated cross section sample can be found in figures 2.8–2.13. Diagrammed photomicrographs of each sample cross section with annotations (under reflected visible and ultraviolet lights) can be found in figures 2.14–2.18.

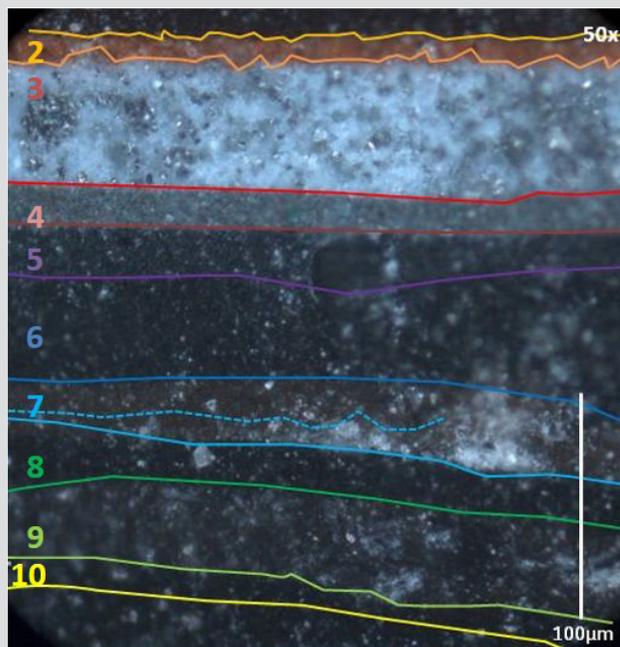
FIGURE 2.8D
House_north cross section microphotograph, with stratigraphic layers numbered (reflected visible light, 50x).

0. Steel, (not included in cross section)
1. Primer, yellow-green (not included in cross section)
2. Primer, orange
3. Corrosion inhibitor
4. Warm gray paint (white, black, red, yellow, blue-green particles), the first exterior paint layer
5. Dark gray paint (black, white, and red particles)
6. Black paint (uniform black particle content)
7. Brown layer, possibly a coating
8. Black paint (uniform black particle content)
9. Dark gray paint (black and white particles)
10. Current paint layer, black paint

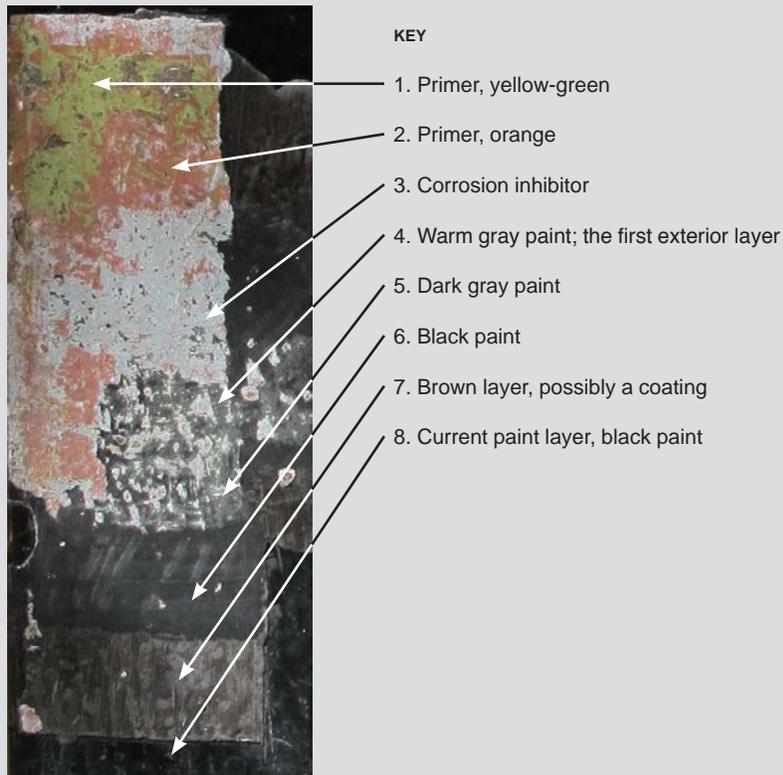
FIGURE 2.10C
House_east_2, in situ paint excavation exposure window with numbered layers.

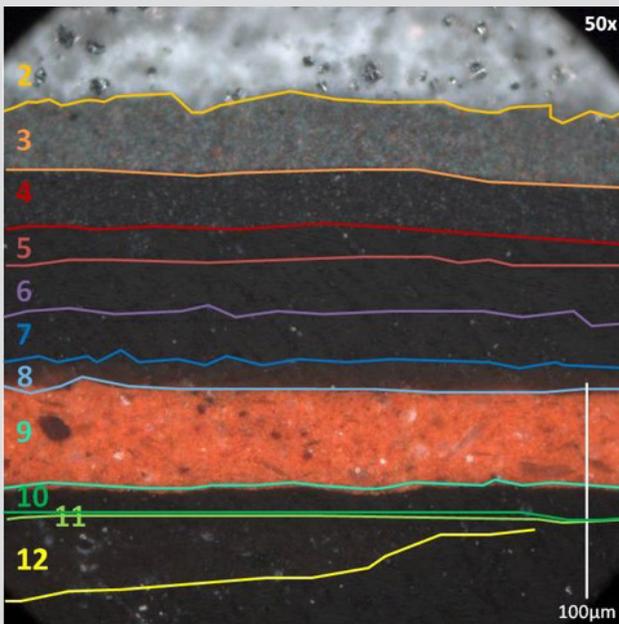
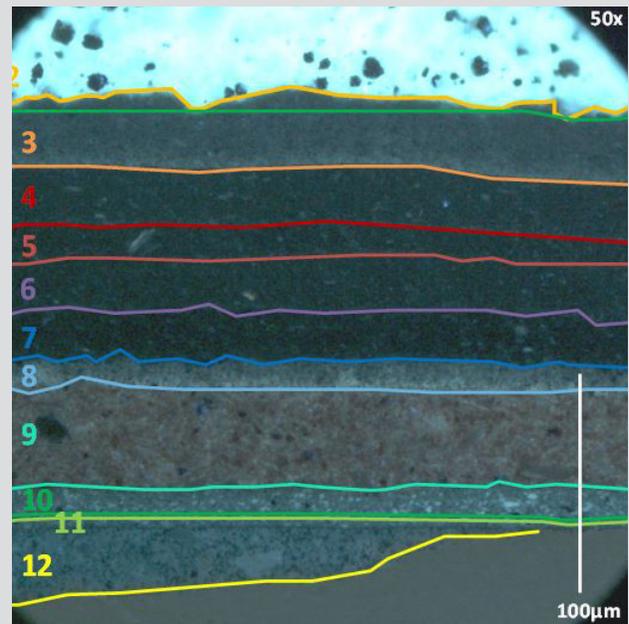
FIGURE 2.15A
House_east, cross section photomicrograph, with stratigraphic layers numbered (reflected visible light, 50x).

FIGURE 2.15B
House_east, cross section photomicrograph, with stratigraphic layers numbered (reflected ultraviolet light, 50x).

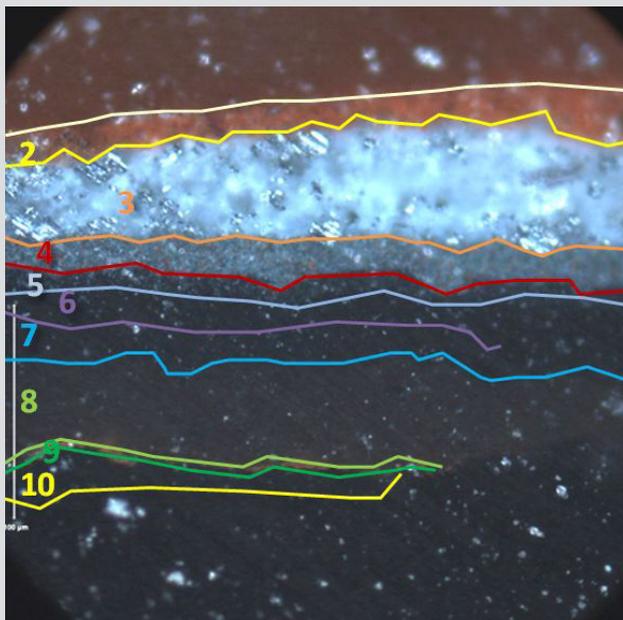
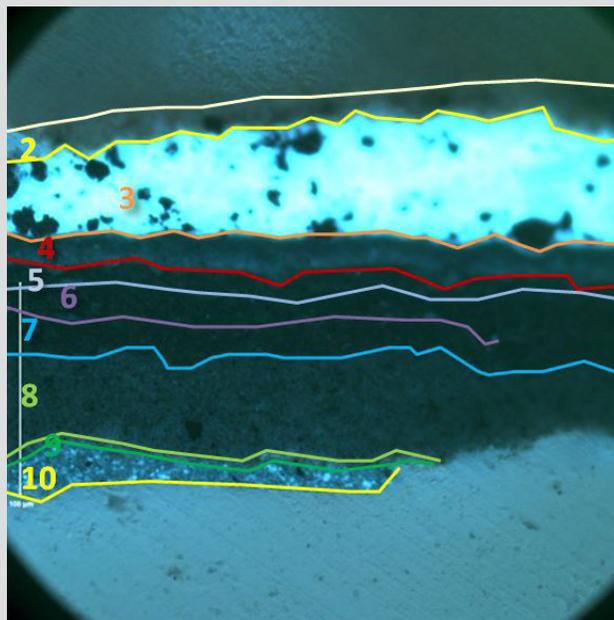
FIGURE 2.18A
Studio_west, cross section photomicrograph, with stratigraphic layers numbered (reflected visible light, 50×).

FIGURE 2.18B
Studio_west cross section photomicrograph, with stratigraphic layers numbered (reflected ultraviolet light, 50×).
