Conservation Issues in Modern and Contemporary Murals

RESEARCH INTO ANTI-GRAFFITI COATINGS FOR ACRYLIC MURALS: PRELIMINARY TESTING AND EVALUATION

E. MACDONALD-KORTH, L. RAINER
AND T. LEARNER

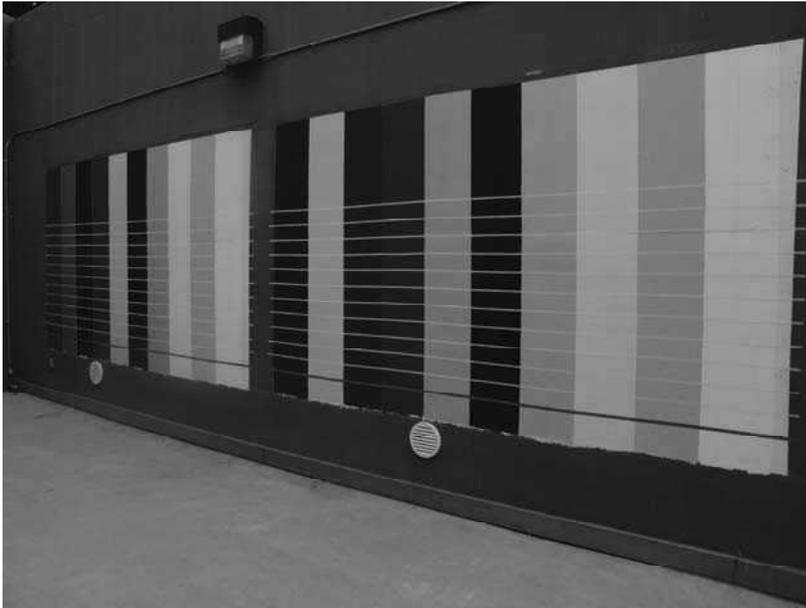
Fig. 1. Test mural design.

project was designed to simulate a conservation treatment in the field, and in doing so, collect realistic, practical results and useful observations regarding the performance of the anti-graffiti coatings employed in the study (Fig.1).

Conservators and scientists from the Getty Conservation Institute (GCI) created three sets of two test murals (six murals total). Each mural measures approximately 2.5 x 3.5 meters. The murals were painted on exterior walls out of public view at the Getty Center, home to the GCI, in Los Angeles (see Figure 1). Each mural was painted using acrylic paints and covered with a clear acrylic varnish. A selection of eleven anti-graffiti coatings was applied to one set of two murals. To assess the performance and effectiveness of the anti-graffiti coatings, a selection of common graffiti materials was applied over the anti-graffiti coatings, and then the graffiti was subsequently removed using methods recommended by the coating manufacturers. The major forms of documentation for the application and removal testing phase included photography, video, and written observations entered on standardized forms designed for the project.

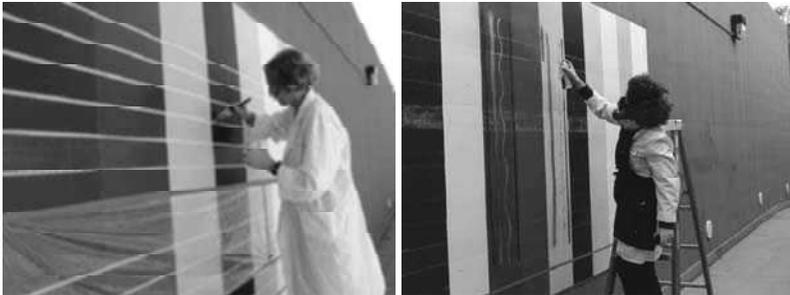
Anti-graffiti coatings can be categorized into two general types, permanent and sacrificial. Permanent anti-graffiti coatings remain on the mural after the graffiti is removed; sacrificial anti-graffiti coatings are removed from the mural along with the graffiti and require reapplication after each graffiti removal. The anti-graffiti coatings in this experiment consisted of six permanent and five sacrificial coatings. Anti-graffiti coatings have many different formulations. The following classes of coatings were included in this study: fluorinated acrylic, polyurethane, acrylate, siloxane, silicone polyester, polysaccharide, and wax. The coatings were applied in horizontal rows over the two test murals. Permanent coatings were applied on the upper section of the mural, and sacrificial coatings were applied on the lower section. (Figs. 2 and 3).

Figs. 2 and 3. Application of the different graffiti materials.

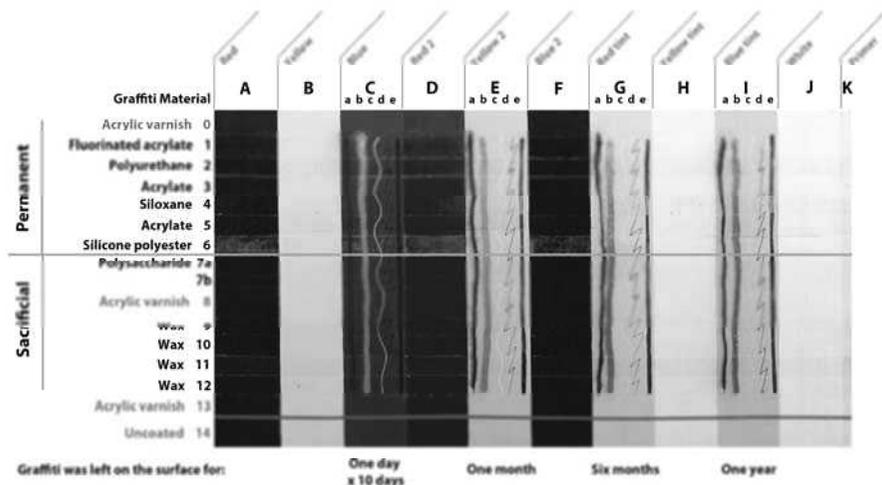
Each test mural is composed of eleven columns and sixteen rows (see Figure 4). Columns were painted in colour stripes as described above, and one distinct anti-graffiti coating was applied to each row¹. A clear varnish was applied over each mural, with one unvarnished row of painted columns at the bottom of each mural. The anti-graffiti coatings were applied horizontally across the mural so that each anti-graffiti coating covered a section of every painted and varnished column. Each graffiti material was applied vertically, on four of eleven columns, over the anti-graffiti coatings (Fig. 3). The four graffiti columns represented temporal differences. To evaluate potential changes in performance over time, the graffiti was left on the surface for four different time periods prior to graffiti removal. The four time periods for graffiti removal were: one day after application, for 10 successive rounds; one month after application; six months after application; and one year after application. (Fig. 4).

Fig.4. Schedule of the four time periods.

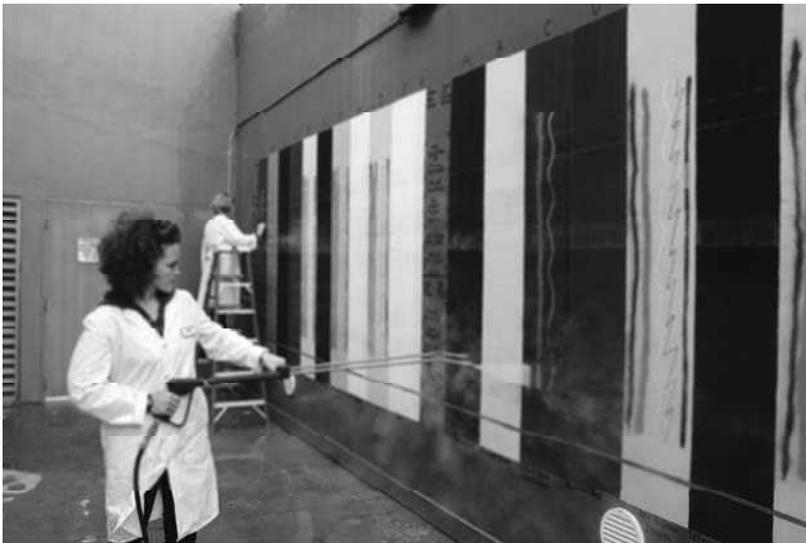
Fig. 5. During the removal process.

Consequently, the use of high-pressure hot water as a first step in all cases was discontinued. Instead, solvent graffiti removers were used for some of the coatings without the high-pressure hot water spray. Using a combination of high-pressure hot water spray, proprietary solvent-based graffiti removers, and various mechanical techniques an effective removal method was developed for each coating (Fig. 5).

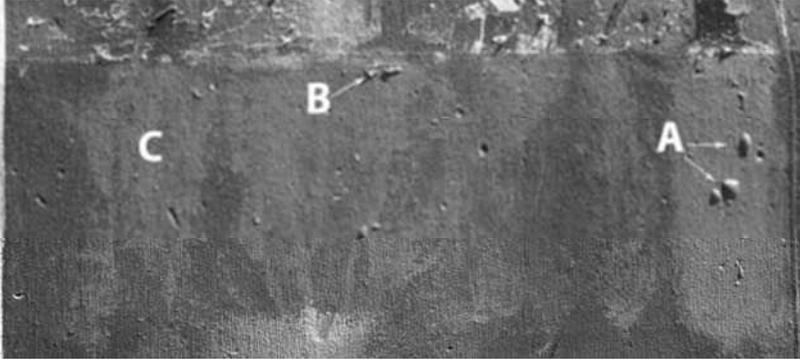
It should also be noted that high heat is inherently unsafe for acrylic murals because it softens the paint, making it more vulnerable to damage. With the addition of high pressure, the situation can become dangerous for the paint. For instance, several of the mural test sections were damaged by the high-pressure hot water treatment: areas of paint were sprayed off the mural creating losses, and some theoretically permanent coatings were inadvertently removed in the same way (Fig. 6). From this testing, it was found that high-pressure hot water was not a good option to safely clean

acrylic murals. However, if the high-pressure hot water spraying unit had fully controllable temperature and pressure settings, then it is possible that a safe setting could be found for each coating (Fig. 6).

Fig. 6. Damaged found after high-pressure hot water treatment.

The high-pressure hot water spraying unit that was used had complications, namely the temperature and pressure of the equipment were not easily regulated and inconsistent. Generally, under high-pressure water spray, the permanent coatings performed better, and sacrificial coatings each performed in a different way (some required very high temperature and low pressure while others required high pressure at any temperature). As a result, when the sprayer did not reach high temperatures or pressures on a certain day, the coatings that require such factors did not perform at their best. Some conclusions can be made about the high-pressure hot water treatment: both the anti-graffiti coatings and the sprayer performed better on warm days, and the second of the two murals to undergo the removal process on any given test day received higher temperature water because the water became hotter during use.

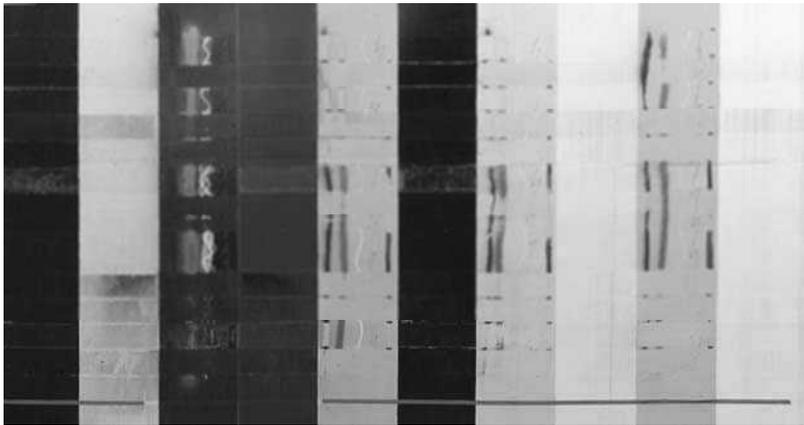
Fig. 7. Solvent-based removal testing.

High-pressure hot water was followed with or preceded by solvent removal, using proprietary removal products made by the coating manufacturers as part of their anti-graffiti coating system. Overall the solvents worked, however it was not possible to acquire some removers because of VOC laws, discontinuation of materials, and limitations on quantity. Although the removal products that were acquired worked well to dissolve the graffiti, in some instances they were also capable of solubilizing the anti-graffiti coating, and swelling or dissolving the mural

paint below. During the removal process, when the surface began to show damage such as deformation, abrasion, or mural paint transferred to the cleaning tool, the removal was halted and the solvent was cleared from the surface. In some cases more graffiti could have been removed, however the solvent-based removal products were difficult to control safely (Fig. 7).
