Beyond Iconography

MATERIALS, METHODS, AND MEANING
IN ANCIENT SURFACE DECORATION

OBSERVATIONS ON MATERIALS AND TECHNIQUES USED IN ROMAN WALL PAINTINGS OF THE TABLINUM, HOUSE OF THE BICENTENARY AT HERCULANEUM

*Francesca Piqué, Emily MacDonald-Korth,
and Leslie Rainer*

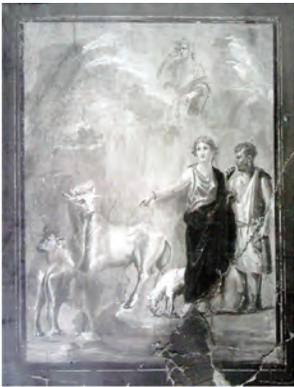
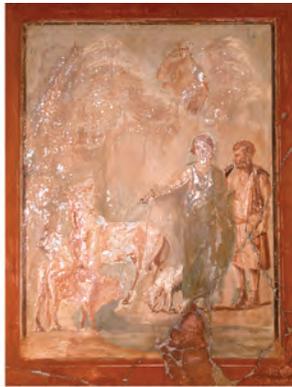
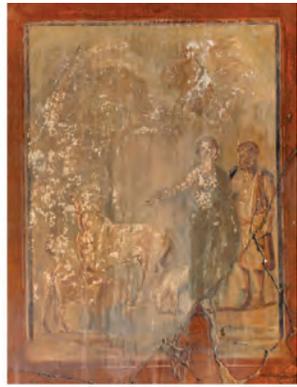
Fig. 1 (opposite top). Central scene, west wall, tablinum, House of the Bicentenary, Herculaneum. Images from three dates, showing changes in condition, and deterioration over time. (1a. Amedeo Maiuri, ca 1938, SAPES Archives, 2779; courtesy of the Ministero per i Beni e le Attività Culturali - Soprintendenza Speciale per Pompei, Ercolano e Stabia. 1b. Archivio Foglia, 1990. 14946b; courtesy of the Ministero per i Beni e le Attività Culturali - Soprintendenza Speciale per Pompei, Ercolano e Stabia).

Deterioration of the wall paintings includes powdering, abrasion, and flaking. In particular, the figurative scenes exhibit severe powdering and flaking, and significant loss of the design layer can be observed when compared to images taken at the time of excavation and reconstruction. Preliminary conclusions are that the current condition of the paintings is related to exposure to fluctuating environmental conditions, the history of interventions (particularly the application of surface coatings), and lack of maintenance, as well as the original painting technique. This last facet, in particular, has vast potential for further work on painting practices.

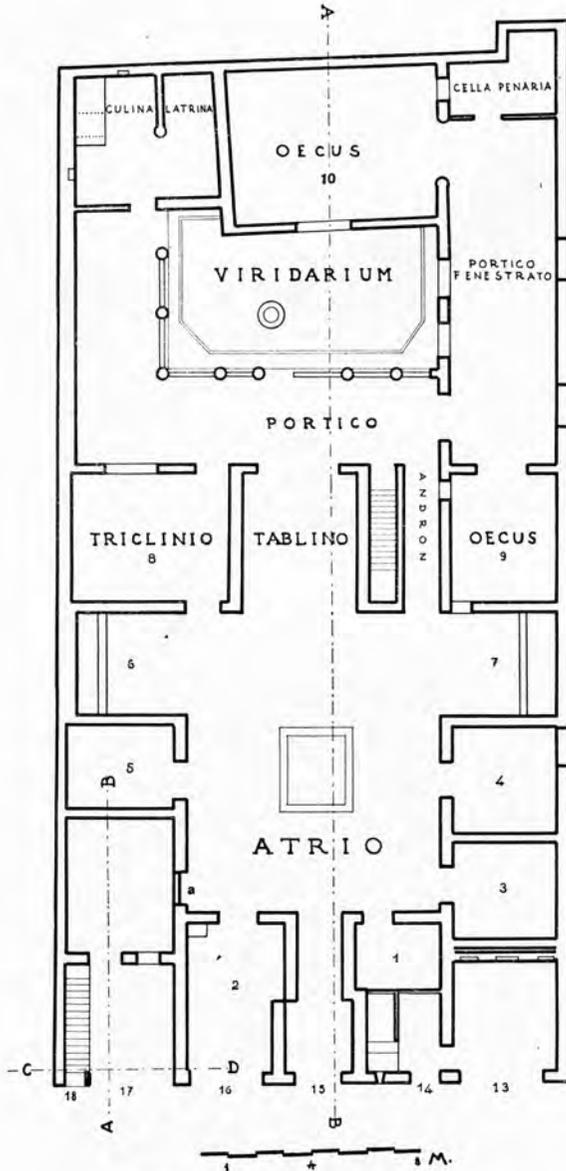
FIG. 174 - CASA DEL BICENTENARIO - PIANTA

Fig. 3. Plan of the House of the Bicenentary. (Maiuri 1958, 222, fig. 174).

decoration in detail and concludes that it is among the most beautiful in elegance and style at Herculaneum.⁸ This important house includes a tablinum (reception room) between the atrium and the peristyle garden, a typical feature of Roman architecture (fig. 3). The tablinum, approximately 4 × 4 m, is

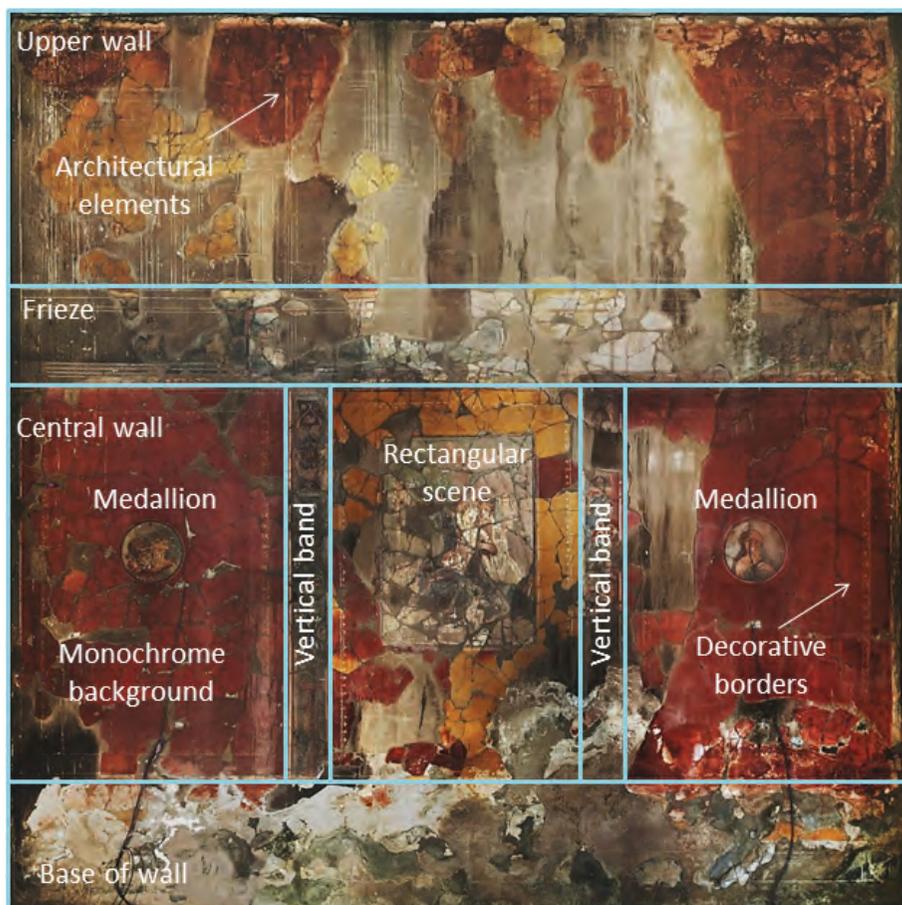
Fig. 4. Schematic division and naming of wall painting decoration. Pictured: East wall, Tablinum, House of the Bicentenary, Herculaneum (photo by M. Brizzi/HCP).

The walls are divided into three horizontal zones, which on the east and west walls are divided by vertical bands (fig. 4). In the upper sections, the paintings depict architectural elements with sculptures, animals, and figures holding garlands. The decoration in this section extends to the upper cornice and ends with a slight curvature where traces of stucco moldings remain, indicating the original existence of a vaulted ceiling, which was probably decorated with stuccoes and paintings like those still visible in other houses at the site. A frieze on a black background, depicting hunting and fishing scenes with cupids, and Amazons fighting on horseback, extends along the three walls and divides the upper and central wall sections.

the polished, or smoothed and compacted surface. Vertical bands (two on the east wall and two on the west wall) cover the seam of the central and side panels. They are painted over the monochrome background and in places directly over the pink-toned plaster with an overall layer of black paint, followed by the upper design layers. Four medallions (two on east and two on west walls) are painted over the monochrome red background with light blue paint, followed by the upper design layers (see fig. 4).

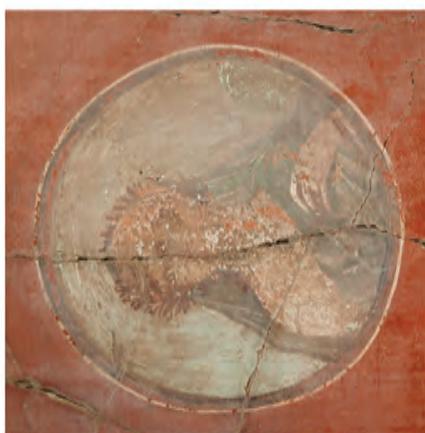
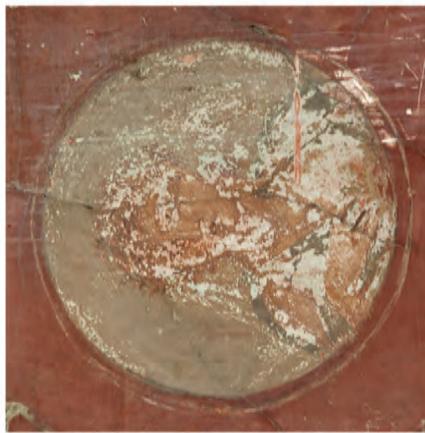
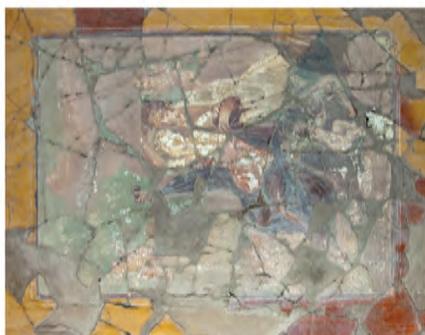
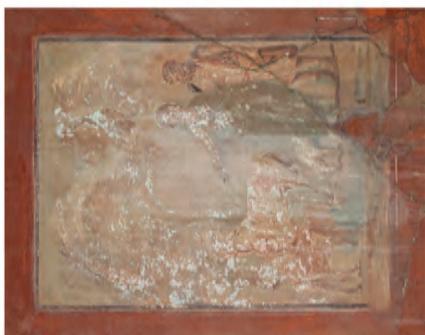
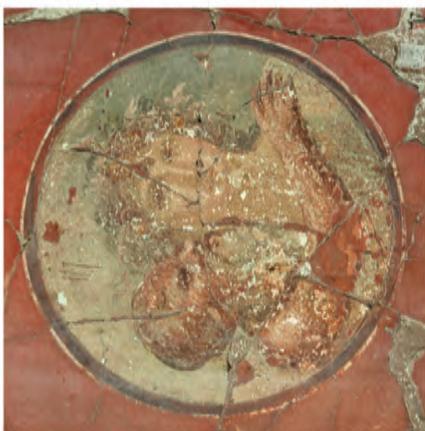
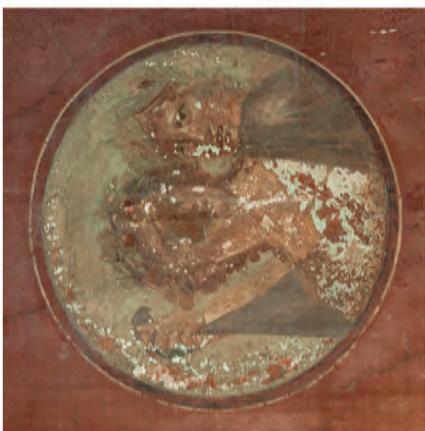
Fig. 5 (opposite). Six figurative paintings; two medallions and one rectangular scene from the east wall and the west wall. Note that the photos are at different scales. For scale, see fig. 4.

The central section of the east and west wall is divided into three panels. On the east wall the background of the central panel is yellow with some areas of heat-altered red, while the background of the central panel on the west wall is red, most likely an original yellow completely transformed to red by the heat of the eruption. Each wall has a rectangular figurative scene in the central panel and is flanked by side panels with figurative paintings in roundels or medallions (fig. 5). The rectangular scene in the middle of the east wall depicts Venus and Mars in a rocky setting surrounded by cupids playing with the symbolic weapons of Mars. The medallion paintings on either side of the central panel represent, on the south, a bust of a Bacchante; on the north, busts of a Maenad and an old bearded Silenus (a companion to Dionysus). On the west wall, the central rectangular scene represents Daedalus and Pasiphaë in a pastoral setting with a rocky background, facing a small herd of cows near water.

A male figure is seen above, looking down on the scene. The medallion paintings on either side of the central panel represent, on the north, a bust of a young Bacchante; on the south, busts of a Maenad and a young Satyr.

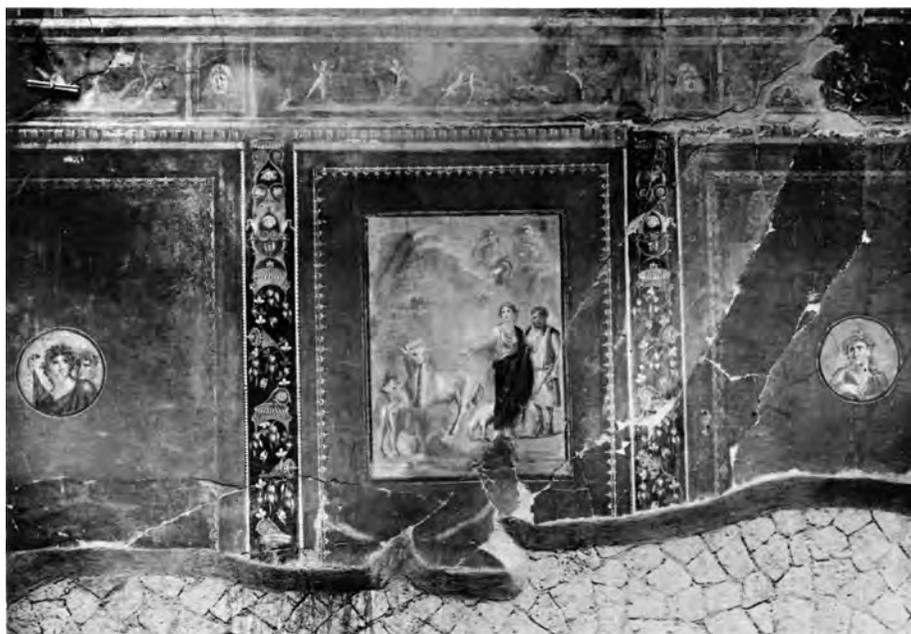
Fig. 6. Central section of the west wall of the tablinum of the House of the Bicentenary after remounting and restoration by Maiuri; photo circa 1940. (Maiuri 1958, 231, fig. 181).

This style of interior decoration is characteristic of Roman wall painting of the fourth style (ca. 50–62 C.E.; fig. 6),¹⁰ and can be found at other archaeological sites in the Vesuvian region such as Pompeii, Oplontis, Stabiae, and in the greater Roman Empire.

Medallions, or figurative paintings in roundels in the center of the side panels, are painted directly over the polished or compacted and smoothed monochrome background layer (which is visible through losses in the background of the medallions) with a series of design layers, executed with a clear impasto and utilizing fine hatching and shading for the figures. As clearly visible in raking light, the outer circle is incised in the plaster using a compass. The entire area within the circle is painted light blue. The light blue paint layer contains lime, dolomite and Egyptian blue pigment. Over the light-blue layer, the figurative elements are painted with bodied paint(s). Vermilion was identified in the flesh tones, hair, and in the lips of some of the figures (see fig. 6).¹⁹

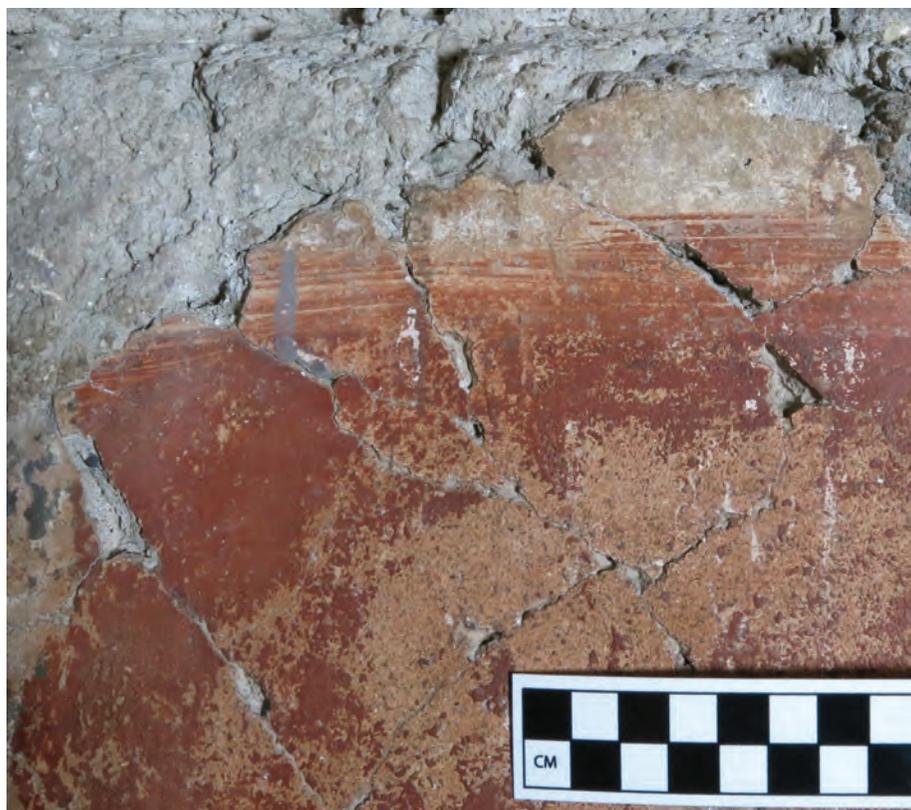
Fig. 7. Upper edge east wall, tablinum, House of the Bicentenary. The image shows the brushstrokes of a light red paint thinly applied over the plaster, at the top of the east wall where it would have been covered by a cornice.

the fresh plaster before it has set. The uppermost layer of plaster has a pink tone, and red particles can be seen in this layer, suggesting that the final plaster layer was toned pink before the application of the monochrome background color. This pink-toned plaster is visible in section and where there are losses to the paintings in areas of red, yellow, and black backgrounds. The background wall color appears to have been applied using the fresco technique by brush across the entire surface of the wall paintings. The background monochrome color is thinner at the edges of the sections where an additional paint layer and/or the cornice decoration was applied and is now missing (fig. 7). The wall sections, (upper, central, and base) appear to have been painted and polished, or compacted and smoothed, prior to the complete setting of the plaster to obtain a very smooth surface.

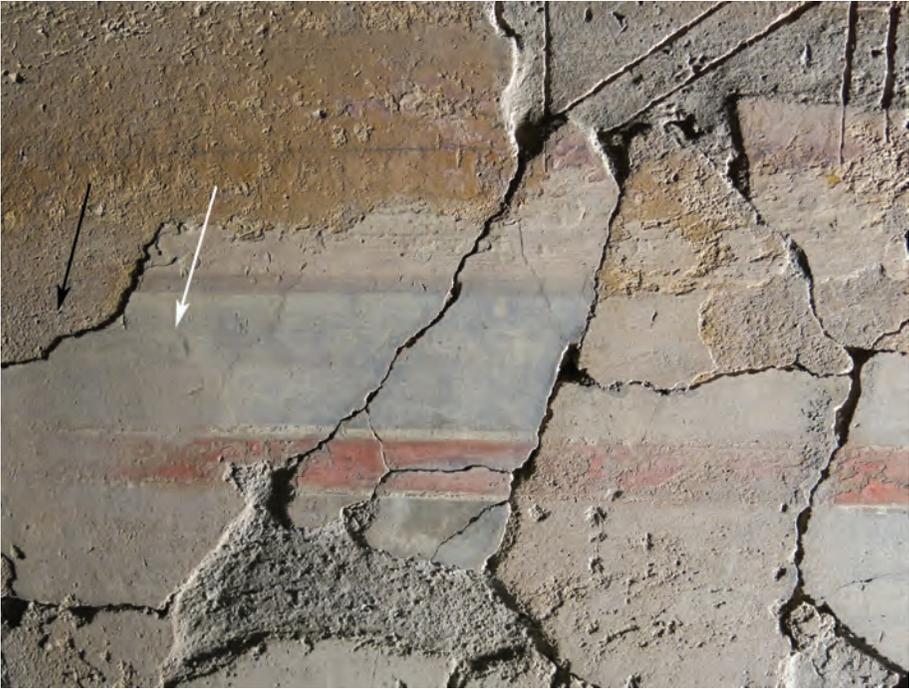
Fig. 8. Detail of frieze decoration on east wall. The added plaster of the frieze is visible in an area of loss where the yellow monochrome background layer of the upper section of the paintings (black arrow) was covered by the frieze plaster (white arrow).

The frieze, which includes fine figurative paintings of hunting scenes, Amazons, and cupids is painted over an additional horizontal plaster band that covers the join of the upper and the lower *pontata* plasters (fig. 8). The black background color of the frieze is also applied in fresco technique and polished or compacted and smoothed. The geometric borders and figures are painted over this background. The edges of the frieze plaster are finished and concealed with a thick layer of paint with additional geometric decorations.

For the frieze, an additional layer of orange-toned plaster was applied horizontally on each wall. This plaster covers the joins of the upper and central *pointas*. The frieze plaster is painted, probably in the fresco technique with a uniform black background. The figurative painting is executed over the black background with a thick-bodied paint. The orange-toned plaster can be seen where the black has worn away. The edges of the frieze plaster layer are concealed by a thick application of paint with decorative borders.

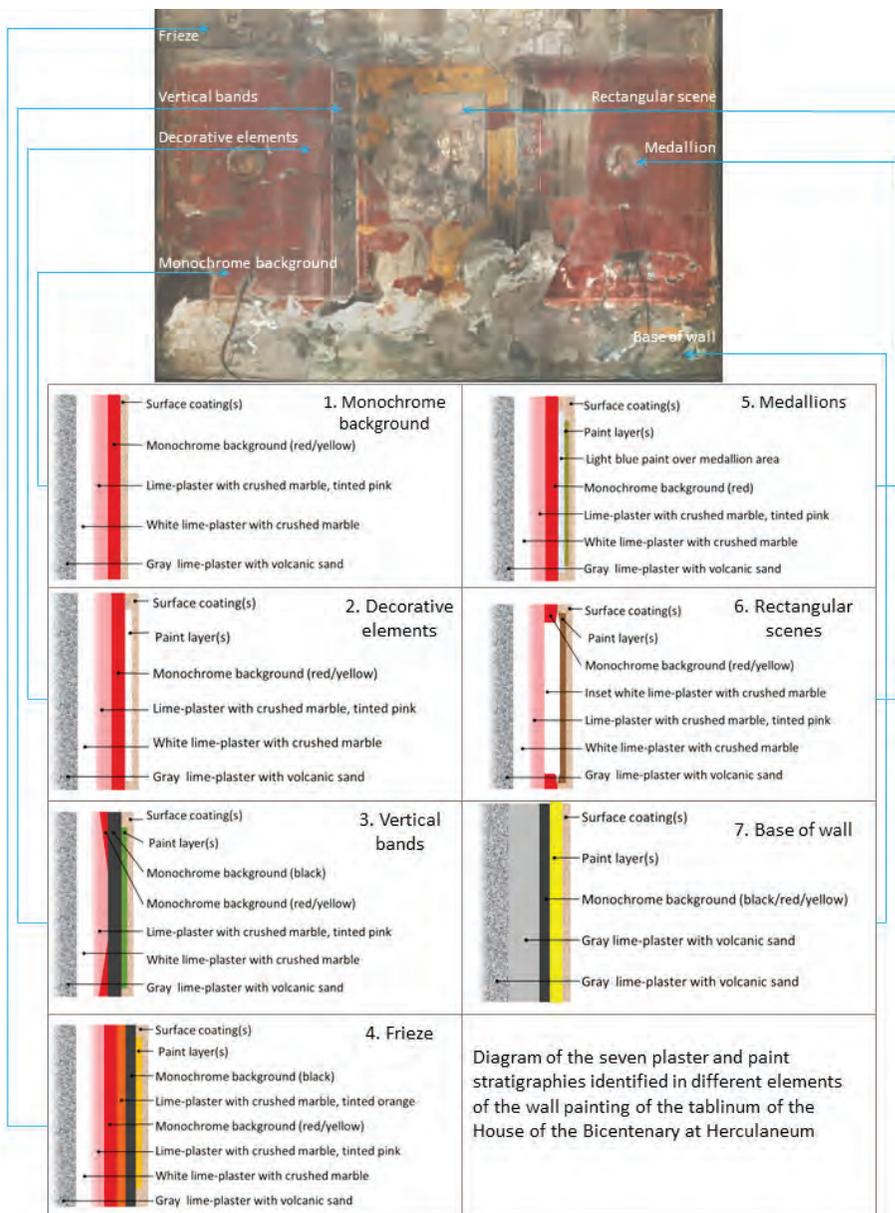
Fig. 9 (opposite). Diagram of plaster and paint stratigraphies identified in different elements of the wall painting of the tablinum of the House of the Bicentenary; lower east wall pictured here. Note: diagrams are not to scale.

Through visual examination of the painted surfaces, it was possible to identify seven different painting stratigraphies: 1. monochrome background; 2. decorative elements over monochrome background; 3. vertical bands; 4. frieze; 5. medallions; 6. rectangular scenes; and 7. base of wall. The original Roman layers of the various stratigraphies are described

from the outer layer inward (fig. 9). Each description includes, over the original paint, surface coatings (mainly composed of natural wax and paraffin) applied after the excavation and periodically over the years to saturate and to protect the wall paintings.¹³

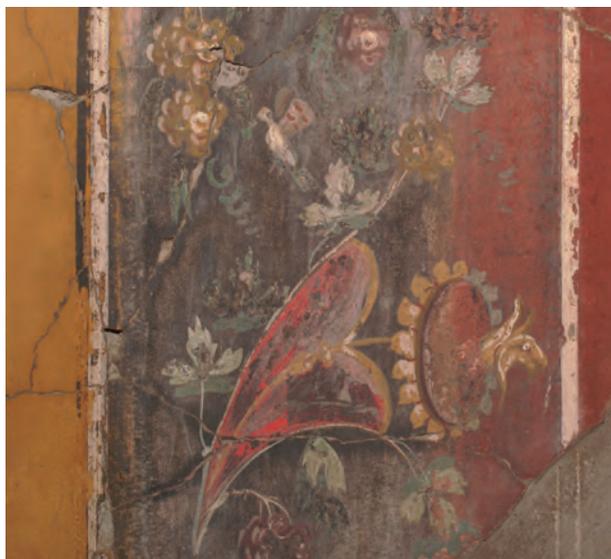
Fig. 10. Detail of vertical band on the east wall. This image shows (on the left) a section of the yellow monochrome background with a white decorative border, and (in the center) a section of a vertical band showing the overall black background color and upper paint layers. The red monochrome under the black can be seen where the black pigment has been lost. Vermilion was identified in the central floral decoration shown and has partially darkened.

walls, consisting of a black background painted over the monochrome background, followed by multiple, bodied, brushed design layers, depicting floral, animal, and fantastic elements (fig. 10). The vertical bands separate the central and side panels and cover the area where the two panels join. This is most evident on the east wall where the central panel is yellow and the side panel is red, and areas of yellow and red can be seen in places where the black has worn or washed away. The pink-toned plaster, which is also found under the red monochrome layer can be seen in losses to the design layer at the center of the vertical bands.
