# The Getty Conservation Institute Project to Conserve David Alfaro Siqueiros's mural *América Tropical*

*Emily MacDonald-Korth and Leslie Rainer*

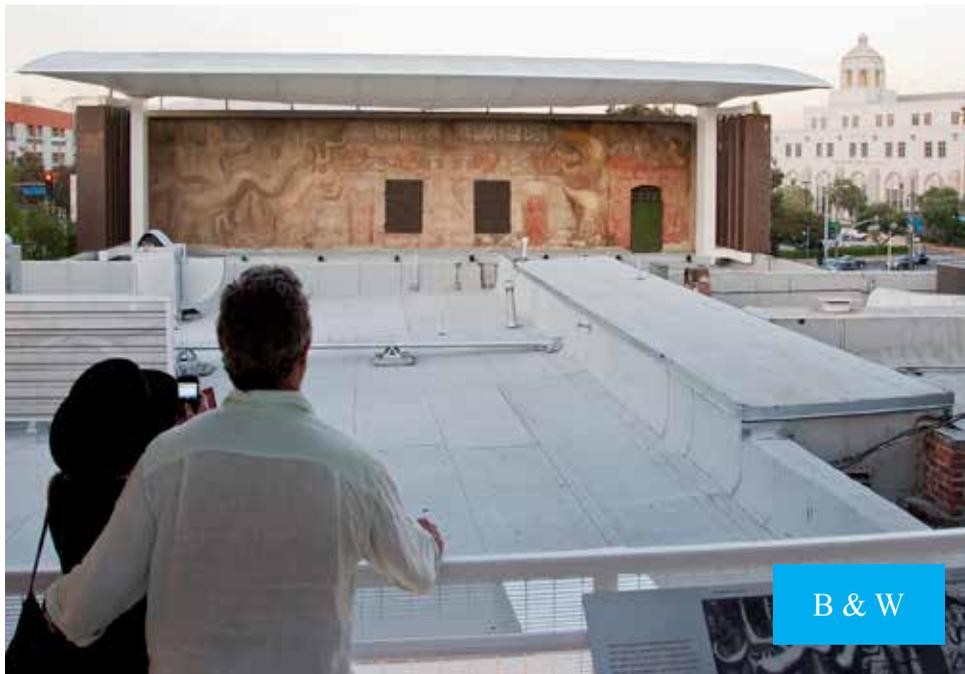
**Fig. 1.** David Alfaro Siqueiros (Mexican, 1896–1974). *América tropical*, modified fresco on cement plaster, 1932, digital composite image from historic black-and-white photographs ca. 1932. Photo courtesy of Thomas Hartman, IQ Magic; mural: © 2012, Artists Rights Society (ARS), New York/Sociedad Mexicana de Autores de las Artes Plásticas (SOMAAP), Mexico City

The mural *América tropical*, by David Alfaro Siqueiros, painted in 1932 and white-washed soon thereafter, is considered to be an early masterpiece by the artist, and it is the only mural by Siqueiros in the United States accessible to the public in situ in its original location (fig. 1).<sup>1</sup> However, its complicated history of artistic experimentation and censorship, as well as decades of harsh environmental exposure, resulted in significant deterioration. From the 1960s on, art historian and social activist Shifra Goldman's work to preserve *América tropical* eventually led to an interest in its preservation by El Pueblo Historical Park and curator Jean Bruce Poole. Their efforts led to a collaborative project, initiated by the Getty Conservation Institute (GCI) and the City of Los Angeles in 1988, to develop and implement a comprehensive plan to protect, preserve, interpret, and present *América tropical* to the public. Conservation of the mural included documentation, scientific study, treatment, and long-term monitoring and maintenance. The aim of conservation was to stabilize and conserve the mural in order to preserve the authenticity of the artist's hand and to tell its tumultuous story, and to reinstate the legibility of the composition; both the iconography and the history of the mural are intrinsic to its appearance. To protect the work, a canopy was designed, consisting of a fabric-covered steel space frame supported by two columns that allow for an unobstructed view of the mural from a viewing platform on a nearby rooftop (fig. 2). Side shades are incorporated into the design to further protect the mural from direct sunlight, and a roll-down screen can be lowered when the site is closed to the public.<sup>2</sup>

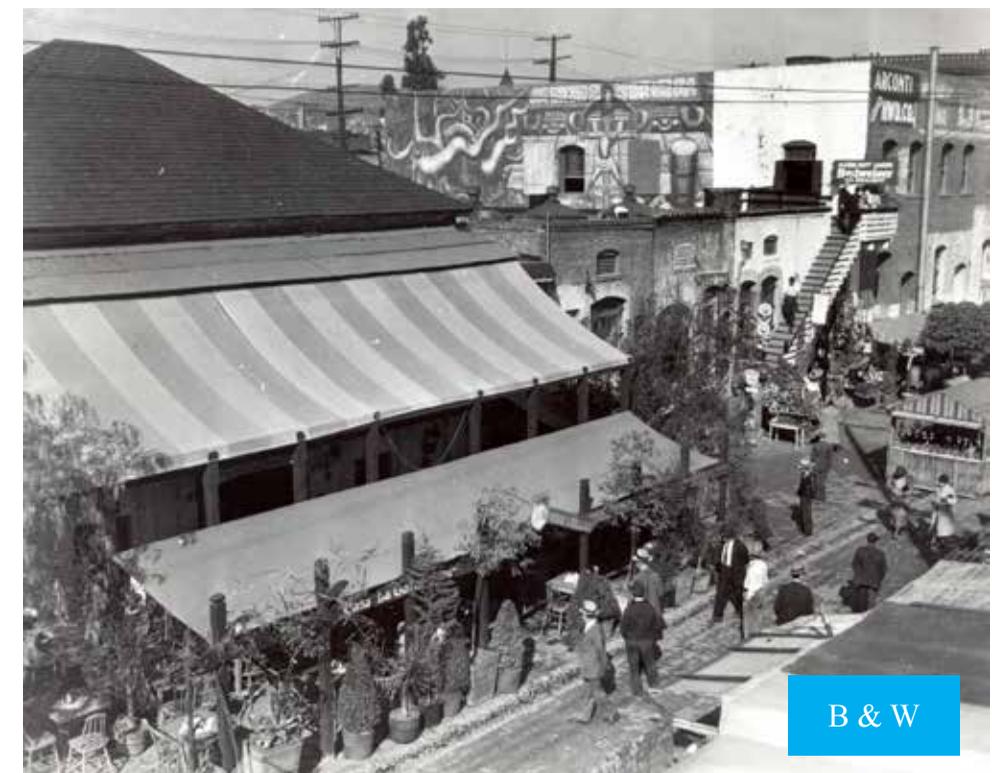
**Fig. 3.** *América tropical* after partial whitewashing, ca. 1934. Photo: © Los Angeles Times, photo published 22 June 2004; mural: © 2012, Artists Rights Society (ARS), New York/Sociedad Mexicana de Autores de las Artes Plásticas (SOMAAP), Mexico City

Painted in 1932, *América tropical* was met with critical acclaim when it opened to the public. Siqueiros, already a well-known artist at the time, had created a massive work, experimenting with an innovative technique of fresco on cement and using new technologies, including pneumatic tools, airbrush, and projectors to prepare and execute the painting.<sup>5</sup> However, he had also depicted a powerful and controversial scene of a peasant hanging on a double cross with a menacing eagle looming above and revolutionaries with rifles aimed at the bird—all in an overgrown jungle and amid ruins of a Mesoamerican temple. In response to this provocative imagery and incendiary political statement, the mural was whitewashed shortly after its completion (fig. 3).<sup>6</sup> For nearly three decades, *América tropical* was covered over and left exposed on the exterior second story of the Italian Hall in downtown Los Angeles. By the 1960s, exposure to the elements and deterioration of the whitewash began to reveal the mural underneath (fig. 4). At this time, a group of interested scholars and artists led by art historian and social activist Shifra Goldman began efforts to preserve the mural. In 1971, two conservators from Mexico—Jaime Mejía and Josefina Quezada—examined the mural and determined that it could be stabilized and conserved but that it could not be restored to its original appearance due to the extent of paint loss,<sup>7</sup> which would require extensive repainting over much of the

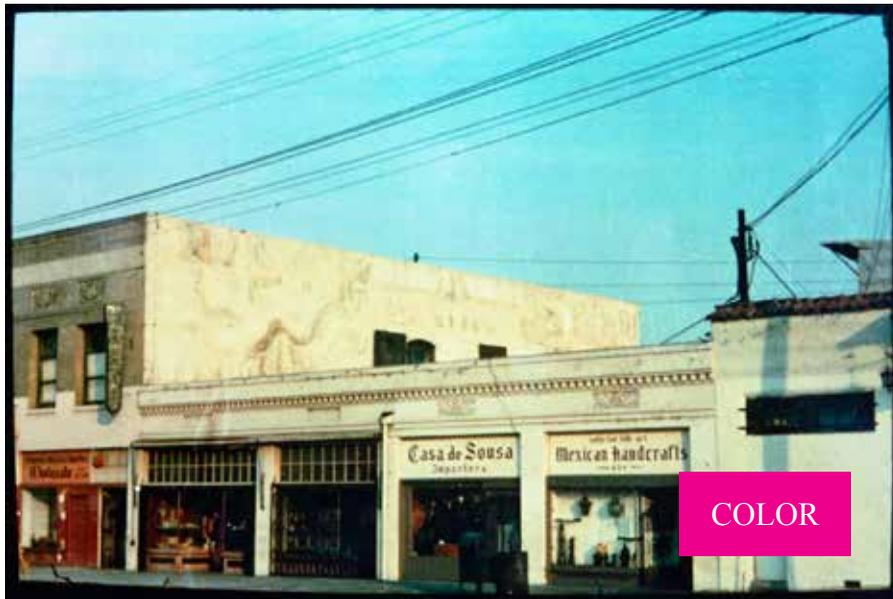
**Fig. 4. View of *América tropical*, ca. 1968, as seen from Main Street, revealing the mural with the deterioration of the whitewash.** Photo courtesy of Shifra Goldman; mural: © 2012, Artists Rights Society (ARS), New York/Sociedad Mexicana de Autores de las Artes Plásticas (SOMAAP), Mexico City

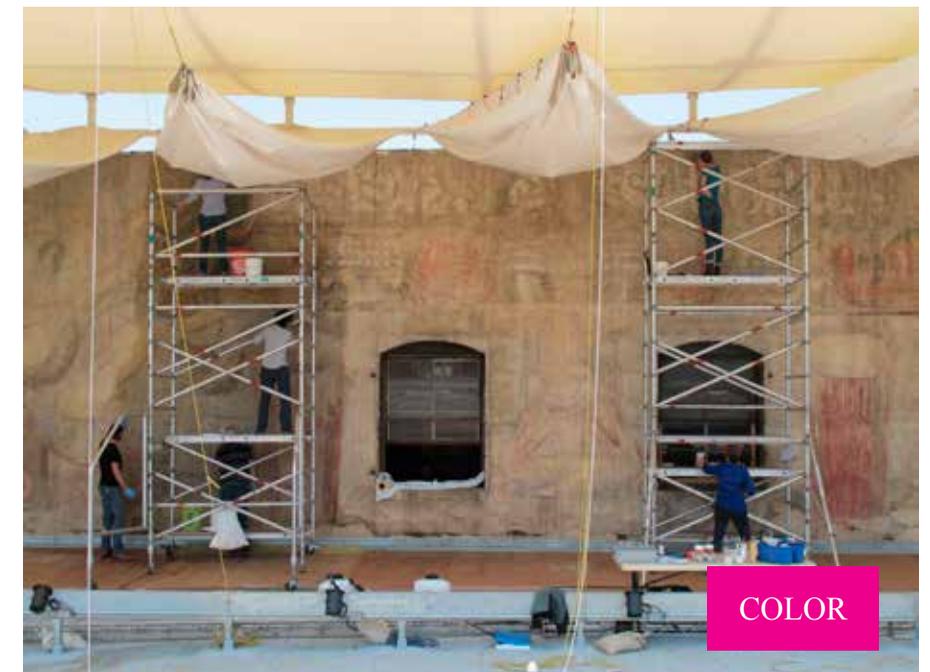
**Fig. 5. GCI conservation team performing treatment on *América tropical* in 2012.** Photo: © J. Paul Getty Trust; mural: © 2012, Artists Rights Society (ARS), New York/Sociedad Mexicana de Autores de las Artes Plásticas (SOMAAP), Mexico City

The aim of the 2012 treatment was to stabilize the mural and to perform limited visual reintegration in order to reinstate the legibility of *América tropical* (fig. 5). The treatment was carried out in steps: the surface was cleaned; discolored surface coatings

and tar deposits were reduced or removed, where possible; voids behind the plaster layer were grouted; plaster losses were filled; the surface was consolidated to reinstate cohesion of the paint and to create a barrier between the original paint layer and the conservation inpainting; and, finally, the design layer was reintegrated. With minimal intervention—as little as possible but as much as needed—conservation and sensitive visual reintegration minimized areas of damage, connecting dots to reinstate the continuity of the composition without fully restoring it.

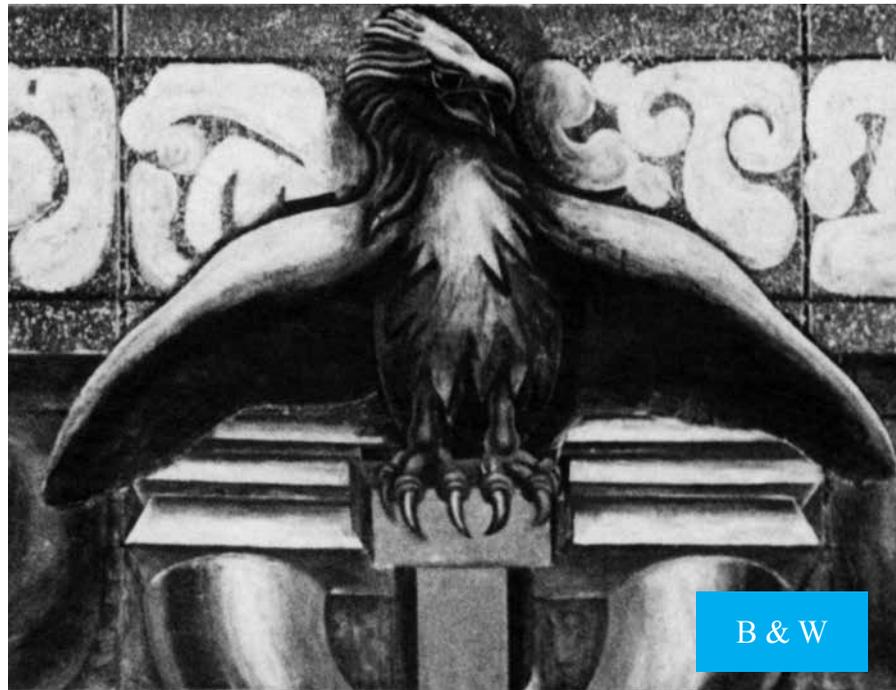
**Fig. 6. Historic black-and-white detail of eagle from *América tropical*, ca. 1932.** Photo: IQ Magic; mural: © 2012, Artists Rights Society (ARS), New York/Sociedad Mexicana de Autores de las Artes Plásticas (SOMAAP), Mexico City

inpainting problem because it was hard to understand where the existing islands of paint were positioned in the original composition—even when looking at historical reference images taken just after the mural was painted. By superimposing current and historical images of details in digital-imaging software and actively adjusting the opacity of the image layers, conservators were able to locate forms and islands of original paint that remained on the surface. This approach allowed the team to accurately connect the dots with inpainting in order to subtly reinforce the imagery of the mural and to reinstate the legibility of the composition (figs. 6–8).

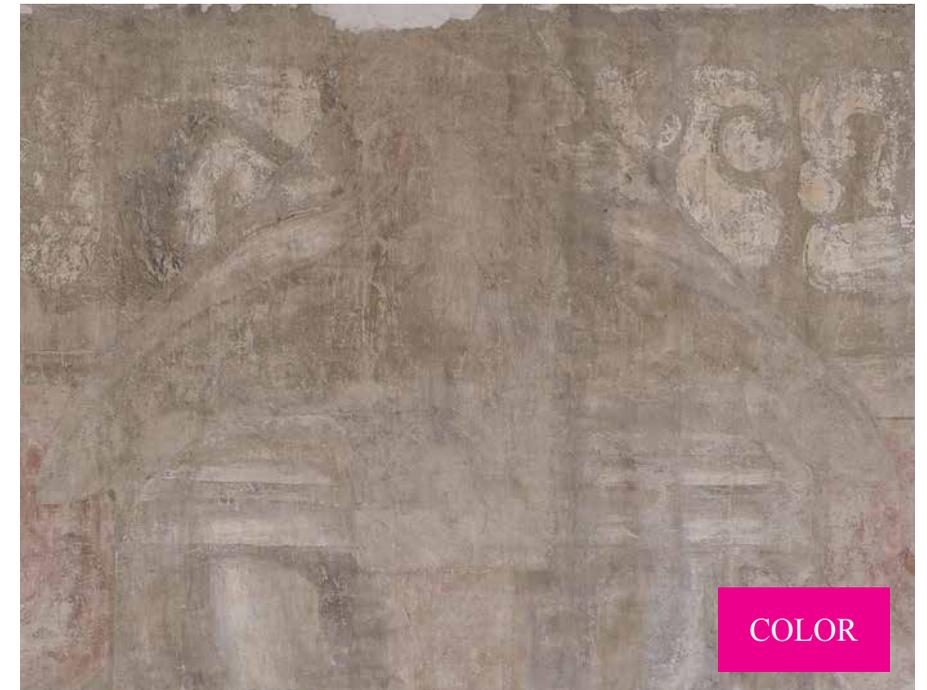
**Fig. 7. Detail of eagle before visual reintegration, 2012.** Photo: © J. Paul Getty Trust; mural: © 2012, Artists Rights Society (ARS), New York/Sociedad Mexicana de Autores de las Artes Plásticas (SOMAAP), Mexico City

Conservators applied dots of chemically stable, reversible, conservation-grade inpainting media (pigments in a resin binder) to connect areas of extant paint in order to reintegrate losses and reinforce shapes and forms, resulting in an increased legibility of the imagery. This sympathetic reintegration gives continuity to the composition from a distance but can be distinguished by the educated viewer upon close examination. Given the overall degradation of the surface, determining the extent of the inpainting was a challenge. The mural's complicated and fragmentary surface created a puzzling

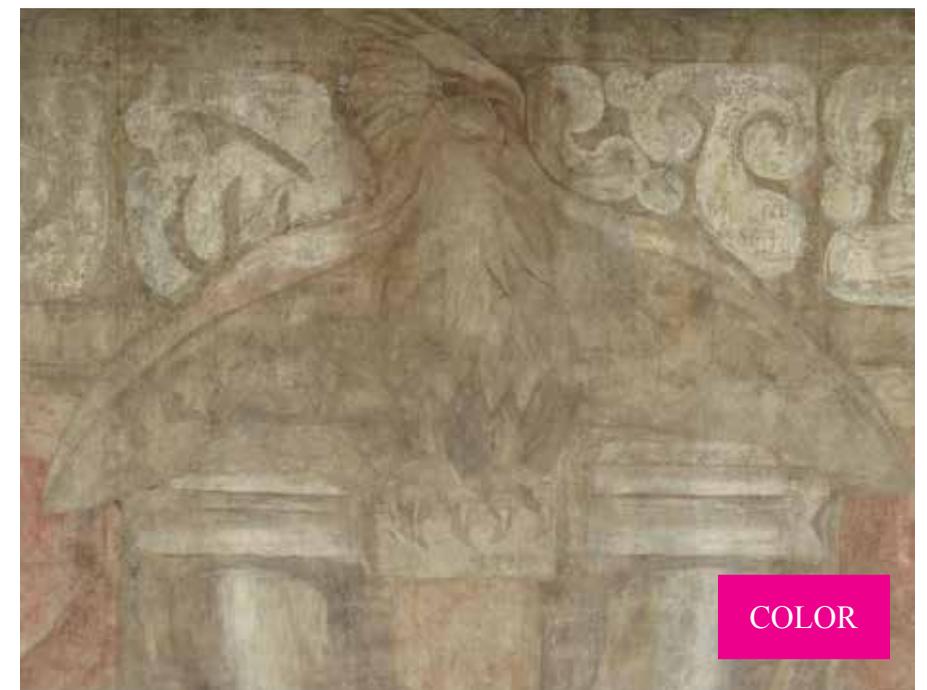
**Fig. 8. Detail of eagle after treatment, 2012.** Photo: © J. Paul Getty Trust; mural: © 2012, Artists Rights Society (ARS), New York/Sociedad Mexicana de Autores de las Artes Plásticas (SOMAAP), Mexico City

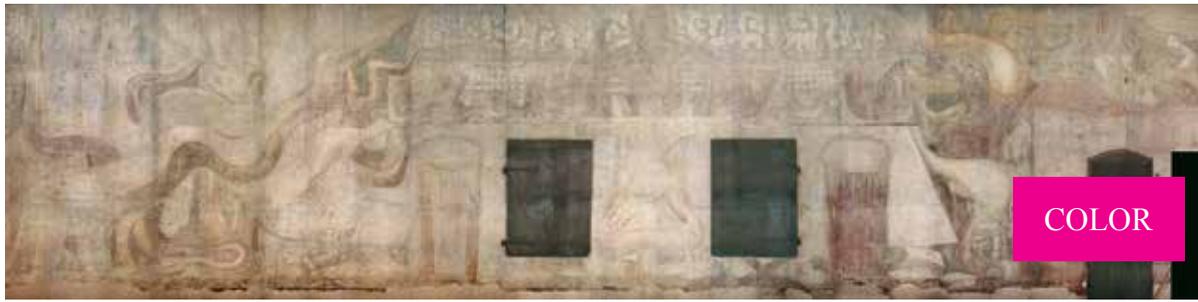
**Fig. 9. Overall image of *América tropical*, following preliminary stabilization, 1994.** Digital composite image from individual tiled sections of the mural. Photo: © J. Paul Getty Trust; mural: © 2012, Artists Rights Society (ARS), New York/Sociedad Mexicana de Autores de las Artes Plásticas (SOMAAP), Mexico City

of the artist and the mural's original context. The mural itself has been stabilized and its iconography has become more legible. Through research and careful conservation practice, conservators have brought *América tropical* back to life by reviving the clarity of its iconography, which reveals the power of its message. At the same time, the hand of Siqueiros has been retained, and the complexity of the mural's history has been preserved (figs. 9, 10).

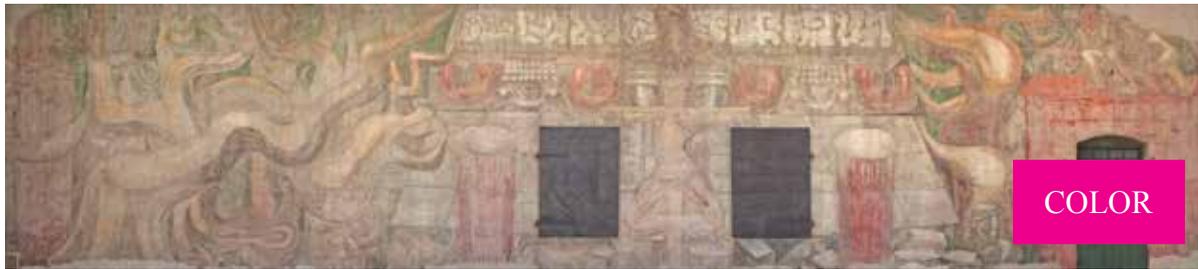
**Fig. 10. Overall image of *América tropical*, after treatment, 2012.** Photo: © J. Paul Getty Trust; mural: © 2012, Artists Rights Society (ARS), New York/Sociedad Mexicana de Autores de las Artes Plásticas (SOMAAP), Mexico City
